**Flood Control Project Maintenance  
Levee Inspections**  
**LMA District Cover Sheet**  
**Spring 2010 Levee Inspection Results**

**Reclamation District No. 2092 Dos Rios**

**Levee Inspection Report By Mile - Spring 2010**

Waterway						Bank	Unit Miles	Inspection Start/End	Inspector
Unit No. 01 San Joaquin River						Right	3.76	05/17/2010 05/17/2010	David Pesavento

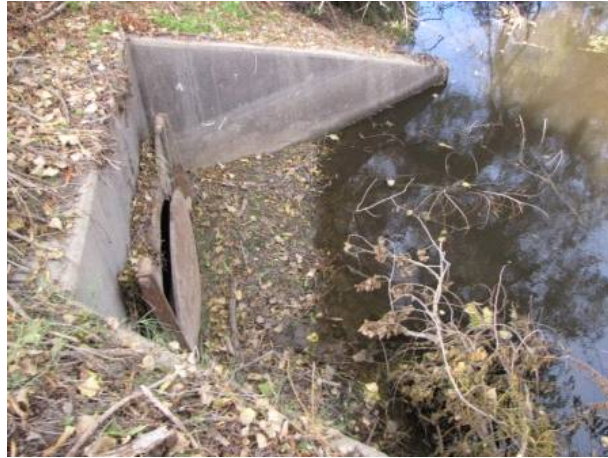
Levee Mile Report Line	2
Start Levee Mile	0.19
End Levee Mile	0.19
Location	Water Side
Category	Interior Drainage & Piping Systems
Item	Flap Gates

View of flap gate stuck open with sedimentation.

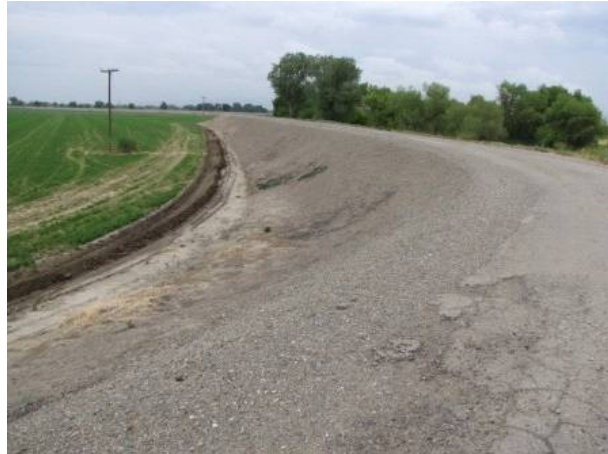
Levee Mile Report Line	6
Start Levee Mile	0.48
End Levee Mile	0.48
Location	Land Side
Category	Earthen Levee
Item	Vegetation

View of good vegetation control on the landward slope.

6	0.48	0.48	Earthen Levee	Vegetation	LS	A	Remove the wild growth other than native grasses from the levee slopes.	37.600986 ° -121.166479 °	37.600986 ° -121.166479 °	6 Y
7	0.77	1.33	Earthen Levee	Encroachments	LS	PO	Agricultural Ditch	37.597291 ° -121.168496 °	37.590568 ° -121.164028 °	968 Y
8	1.34	1.57	Earthen Levee	Encroachments	LS	PO	Agricultural Ditch	37.590479 ° -121.163844 °	37.587758 ° -121.162349 °	7
9	1.55	1.69	Supplemental	DWR Erosion Survey	WS	M	Inspector Comments: 2009: No major change; sloughing at the lower slope that's created a terraced effect; damage could be caused by wave action during an extended flooding; site recommended as local maintenance issue, per CLRO CES Evaluation 2008 Report; previously rated "M" [2009 SiteID:RD2092U1RM84.6]	37.587130 ° -121.162830 °	37.587130 ° -121.162830 °	1 Y
10	1.59	1.87	Earthen Levee	Encroachments	WS	PO	Agricultural Ditch	37.587575 ° -121.162454 °	37.584057 ° -121.162387 °	8 Y

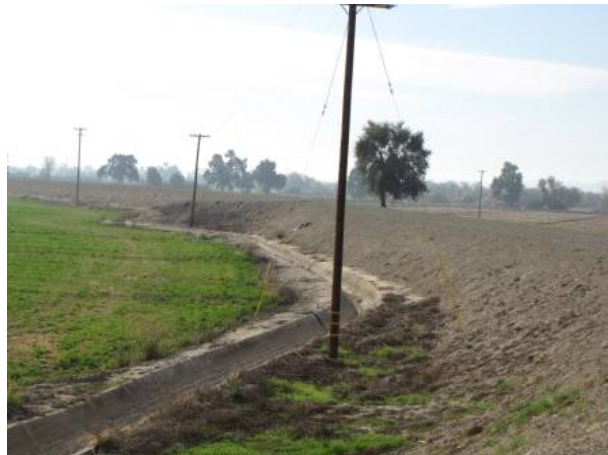
Levee Mile Report Line	7
Start Levee Mile	0.77
End Levee Mile	1.33
Location	Land Side
Category	Earthen Levee
Item	Encroachments

View of agricultural ditch at the landward toe looking upstream.

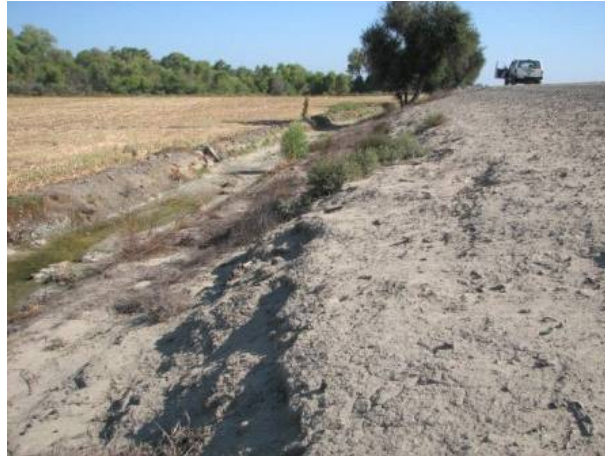
Levee Mile Report Line	9
Start Levee Mile	1.55
End Levee Mile	1.69
Location	Water Side
Category	Supplemental
Item	DWR Erosion Survey
<p>2009: No major change; sloughing at the lower slope that's created a terraced effect; damage could be caused by wave action during an extended flooding; site recommended as local maintenance issue, per CLRO CES Evaluation 2008 Report; previously rated "M" [2009 SiteID:RD2092U1RM84.6]</p> <p>SJR2009_RM84.6U0 082509A.JPG</p>

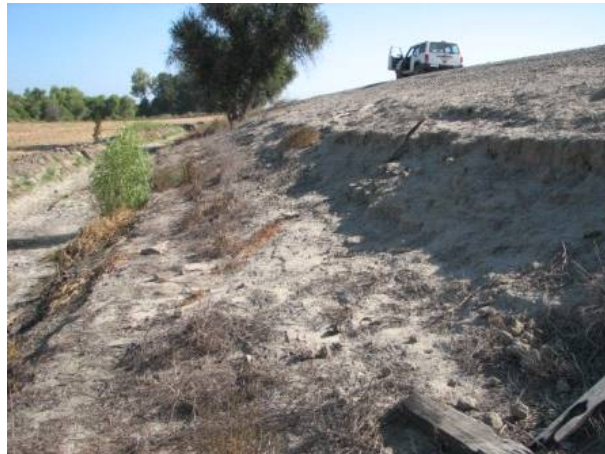
Levee Mile Report Line	9
Start Levee Mile	1.55
End Levee Mile	1.69
Location	Water Side
Category	Supplemental
Item	DWR Erosion Survey
<p>2009: No major change; sloughing at the lower slope that's created a terraced effect; damage could be caused by wave action during an extended flooding; site recommended as local maintenance issue, per CLRO CES Evaluation 2008 Report; previously rated "M" [2009 SiteID:RD2092U1RM84.6]</p> <p>SJR2009_RM84.6U0 082509C.JPG</p>

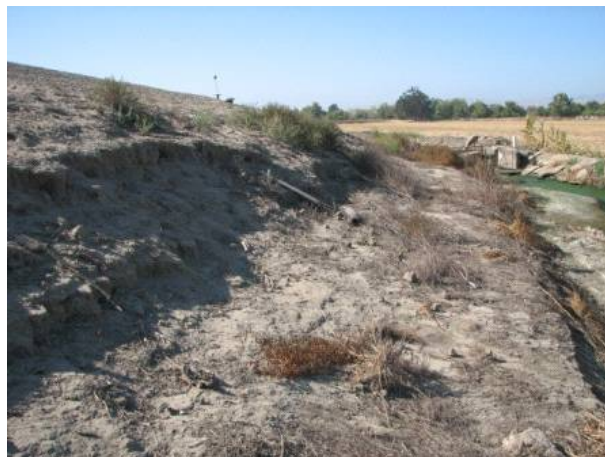
Levee Mile Report Line	9
Start Levee Mile	1.55
End Levee Mile	1.69
Location	Water Side
Category	Supplemental
Item	DWR Erosion Survey
<p>2009: No major change; sloughing at the lower slope that's created a terraced effect; damage could be caused by wave action during an extended flooding; site recommended as local maintenance issue, per CLRO CES Evaluation 2008 Report; previously rated "M" [2009 SiteID:RD2092U1RM84.6]</p> <p>SJR2009_RM84.6U0 082509D.JPG</p>

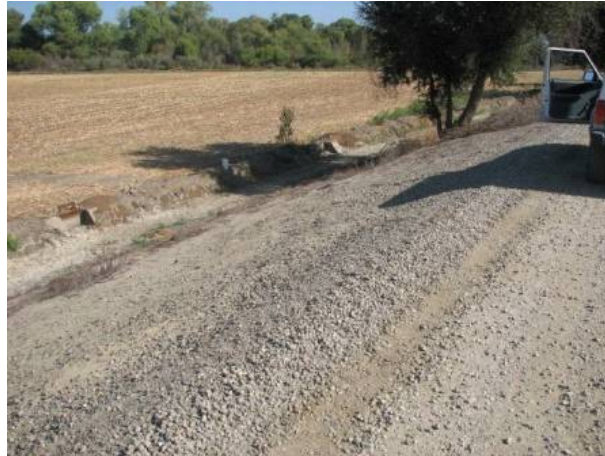
Levee Mile Report Line	9
Start Levee Mile	1.55
End Levee Mile	1.69
Location	Water Side
Category	Supplemental
Item	DWR Erosion Survey

2009: No major change; sloughing at the lower slope that's created a terraced effect; damage could be caused by wave action during an extended flooding; site recommended as local maintenance issue, per CLRO CES Evaluation 2008 Report; previously rated "M" [2009 SiteID:RD2092U1RM84.6]

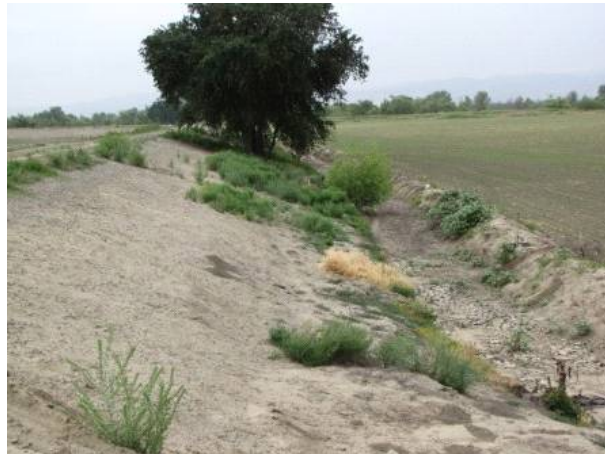
Levee Mile Report Line	10
Start Levee Mile	1.59
End Levee Mile	1.87
Location	Water Side
Category	Earthen Levee
Item	Encroachments

View of an agricultural ditch at the waterward toe of the slope.

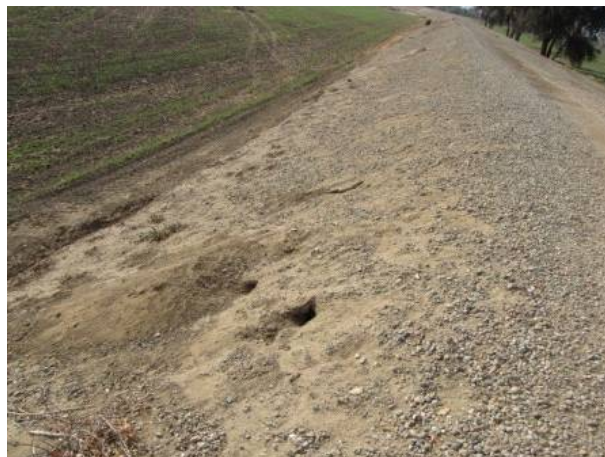
Levee Mile Report Line	11
Start Levee Mile	1.59
End Levee Mile	1.62
Location	Land Side
Category	Earthen Levee
Item	Animal Control

View of rodent holes in landward slope looking upstream.

11	1.59	1.62	Earthen Levee	Animal Control	LS	M	Repair the levee slope damaged by livestock and prevent large animal access.	37.587564 ° -121.162459 °	37.587117 ° -121.162732 °	970 Y
12	1.88	1.88	Earthen Levee	Trim / Thin Trees	LS	N	Tree stumps.	37.584019 ° -121.162135 °	37.584019 ° -121.162135 °	9 Y
13	1.94	1.94	Earthen Levee	Vegetation	LS	M	Control annual grass and weeds on the levee slopes and easements.	37.584277 ° -121.161080 °	37.584277 ° -121.161080 °	10
14	2.06	2.06	Earthen Levee	Vegetation	LS	M	Control annual grass and weeds on the levee slopes and easements.	37.584301 ° -121.159075 °	37.584301 ° -121.159075 °	11
15	2.07	2.07	Earthen Levee	Animal Control	LS	M	No rodents visible, but rodent burrows visible; need to backfill and compact or grout borrows.	37.584295 ° -121.158809 °	37.584295 ° -121.158809 °	971 Y

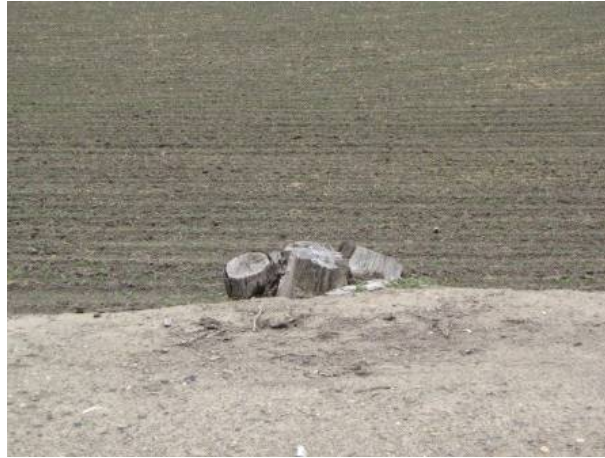
Levee Mile Report Line	12
Start Levee Mile	1.88
End Levee Mile	1.88
Location	Land Side
Category	Earthen Levee
Item	Trim / Thin Trees

View of a stump on the landward slope.

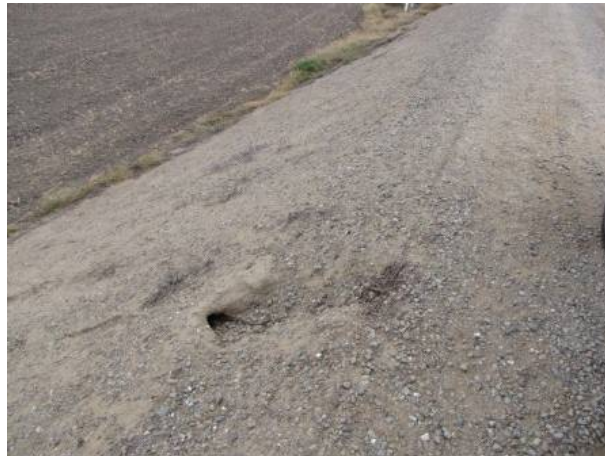
Levee Mile Report Line	15
Start Levee Mile	2.07
End Levee Mile	2.07
Location	Land Side
Category	Earthen Levee
Item	Animal Control

View of rodent holes in the landward shoulder looking upstream.

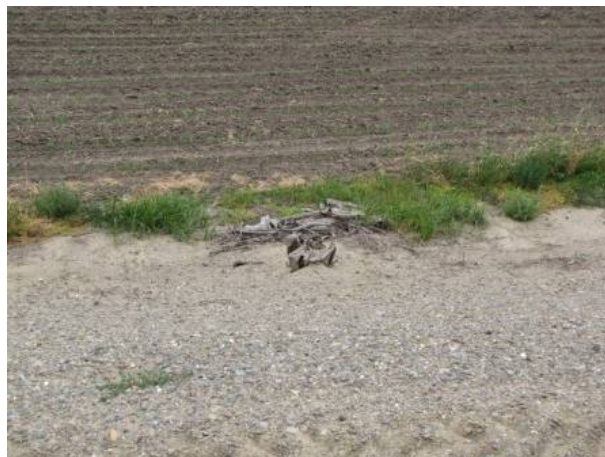
Levee Mile Report Line	17
Start Levee Mile	2.26
End Levee Mile	2.26
Location	Land Side
Category	Earthen Levee
Item	Trim / Thin Trees

View of a stump on the landward slope.

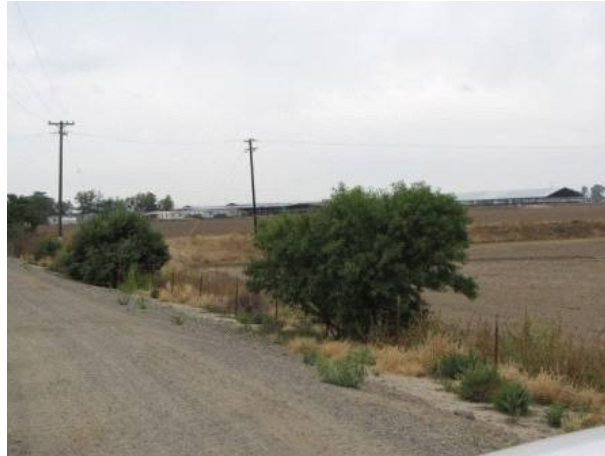
Levee Mile Report Line	21
Start Levee Mile	2.83
End Levee Mile	2.83
Location	Water Side
Category	Earthen Levee
Item	Trim / Thin Trees

View of trees on the waterward slope blocking visibility.

21	2.83	2.83	Earthen Levee	Trim / Thin Trees	WS	M	Trim and thin trees to allow visibility of the ground and room to flood fight.	37.574928 ° -121.156498 °	37.574928 ° -121.156498 °	17 Y
22	2.84	3.09	Earthen Levee	Encroachments	LS	PO	Fences Inspector Comments: Barbed wire fence on landward slope.	37.574973 ° -121.156647 °	37.574001 ° -121.152183 °	972 Y
23	3.40	3.40	Earthen Levee	Animal Control	LS	W	Repair the levee slope damaged by livestock and prevent large animal access.	37.573334 ° -121.147022 °	37.573334 ° -121.147022 °	18
24	3.54	3.70	Earthen Levee	Vegetation	WS	M	Control annual grass and weeds on the levee slopes and easements.	37.573291 ° -121.144391 °	37.573257 ° -121.141446 °	19

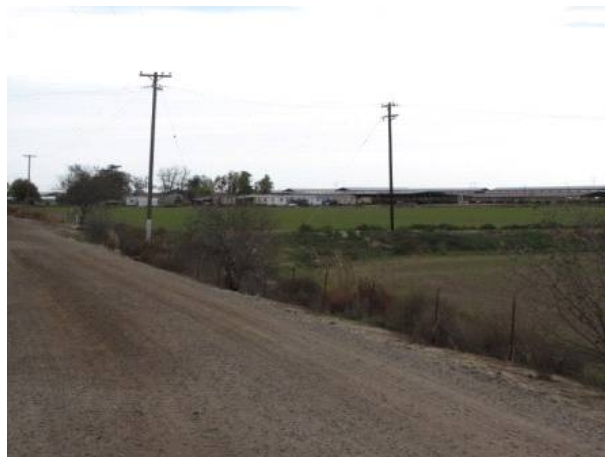
Levee Mile Report Line	22
Start Levee Mile	2.84
End Levee Mile	3.09
Location	Land Side
Category	Earthen Levee
Item	Encroachments

View of barbed wire fence along the waterward slope looking upstream.
